NBS TECHNICAL NOTE 909

Investigation of Wind Damage in the Metropolitan Washington, D.C. Area, April 3-4, 1975

F. Y. Yokel, C. W. Yancey,
L. E. Cattaneo, and R. D. Marshall

A limited investigation was conducted of wind damage that occurred on April 3 and 4, 1975 in the Metropolitan Washington, D.C. area.

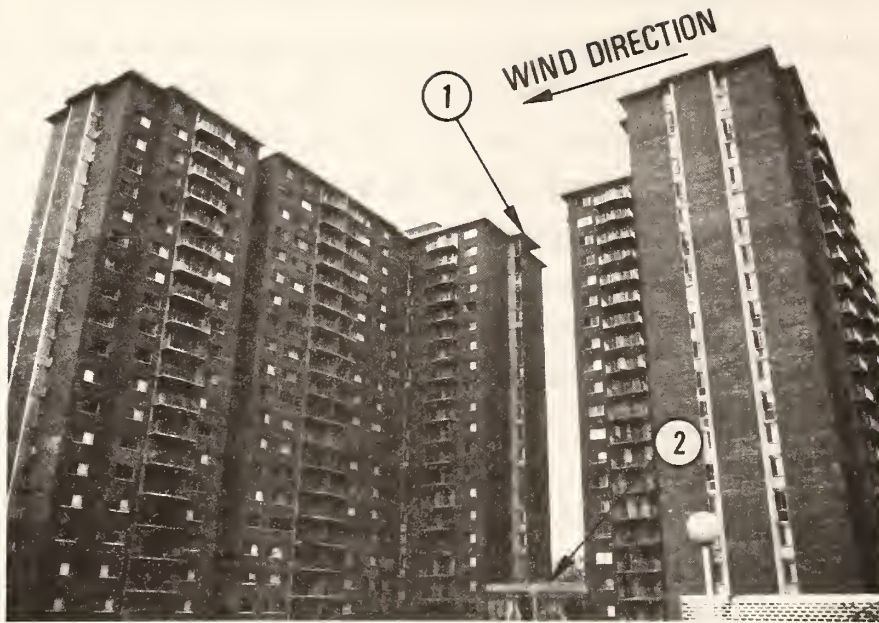
Figure 2 shows the rear elevation of a 19 story apartment building complex. The prevailing wind direction is shown by the arrow at the top of the figure. In this building a masonry wall fell from the location marked 1 into a lobby (location 2) destroying the roof of the lobby. Some of the debris from the wall and the lobby roof resting on the floor of the lobby is shown in figure 3. Figure 4 shows the wall failure in more detail and figure 5 shows an elevation of a similar wall in the opposite wing of the twin buildings which did not fail. The buildings are reinforced concrete structures.

Figure 2 - Damaged areas of high-rise apartment building. Looking south.

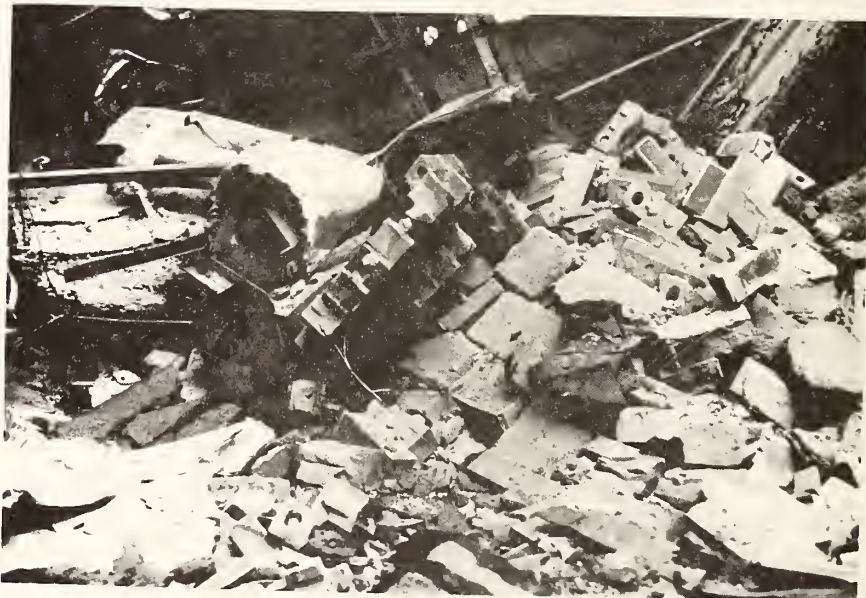
Figure 3 - Partial view of the debris on the floor of the lobby.

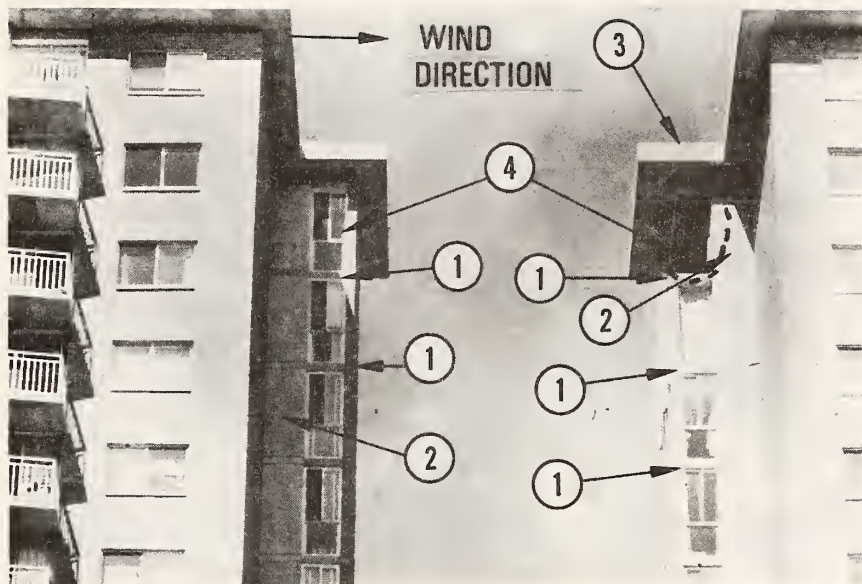
Typically, reinforced concrete flat slabs, marked number 1 in figure 4, are structurally supported by reinforced concrete bearing walls marked number 2 in figure 4. The roof slab, marked number 3 in figure 4 is a reinforced concrete slab which is also supported by the concrete walls and is further stiffened by a reinforced concrete rim beam, marked number 1 in figure 5. The masonry walls are nonstructural curtain walls consisting of one wythe of brick backed up by one wythe of nominally 4 in (10 cm) thick concrete block. Ties between the brick wythe and the concrete block wythe are provided by truss-type horizontal joint reinforcement. There is no vertical reinforcement and the field inspection showed no evidence that reinforcement ties were provided between the masonry wall and the roof or between the masonry wall and the floor slabs. Based on the visual inspection and on occupant accounts the failure mechanism is envisioned as follows: First the window, marked number 4 in figure 4 (see the encircled area on the right hand building) broke inward under the wind pressure, the local wind direction being substantially different from the prevailing direction. Subsequently, outward pressure acted on all the interior surfaces of the room (the opposite window in the same room did not break) and the accelerated flow between the buildings probably resulted in very low pressures acting on the exterior of the wall. In addition to this outward pressure, the roof was quite likely subject to upward pressure on the overhanging part and to suction on the top. The combination of these pressures together with the probable absence of ties between the wall and the roof caused the masonry wall to fail as a cantilever along the top of the floor slab of the uppermost story. Figure 6 shows a portion of the failure surface. It should be noted that the failure surface (near the edge of the floor slab) is clean and smooth with no substantial remnants of the mortar joint above it. This is taken as an indication that the bond between the mortar joint of the concrete block wythe and the floor slab was probably weak. Thus at this cross section, effective moment resistance was provided only by one 3-1/2 in (8.9 cm) wide brick wythe. There was not enough moment resistance available to prevent the wall from failing as a cantilever beam. The weight of the wall section that fell on

Figure 4 - Structural details of the twin buildings. Looking north.

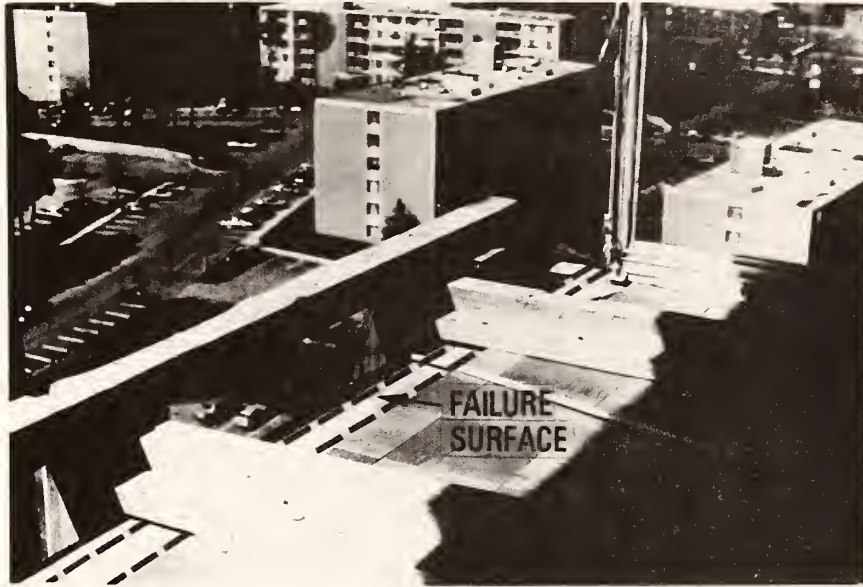
Figure 6 - Failure surface (between dashed lines) on top of floor slab.

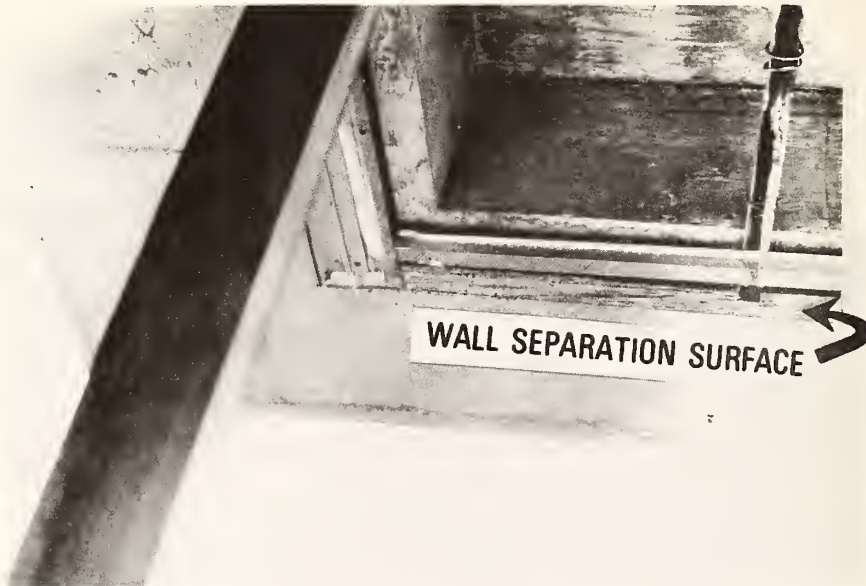
the lobby was considerable and could have caused loss of life. A view from underneath the roof slab is shown in figure 7. Note the concrete rim beam which stiffens the roof slab. The surface where the wall separated is marked by an arrow. It can be reasonably assumed that most of the weight of this portion of the roof slab is transferred by the rim beam to the concrete columns and therefore only a minor part of this weight rests on the masonry wall. Thus no substantial frictional force would resist the outward movement of the top of the masonry wall. Other views of the failure are provided in figures 8 and 9.

Figure 7 - Surface of separation between rim beam and top of wall. Looking at underside of roof slab.

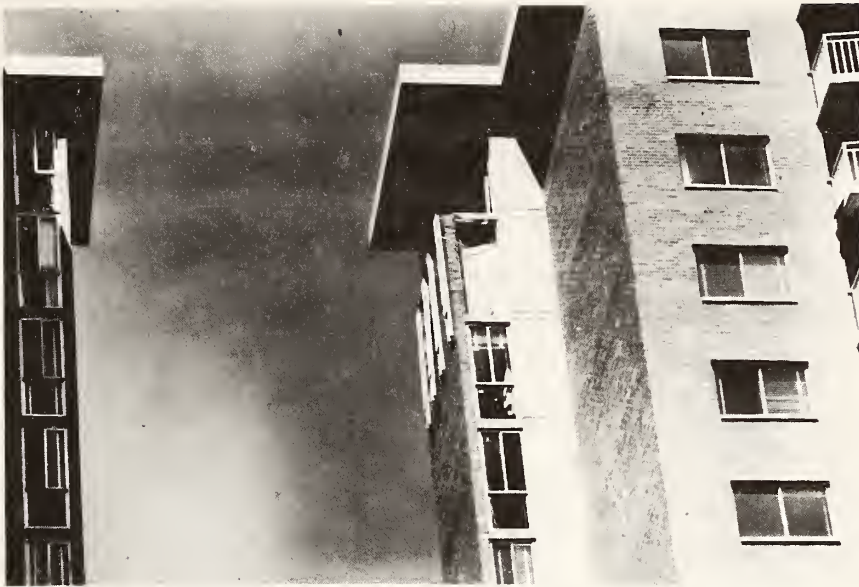
Figure 8 - View of upper-story damage. Looking north.

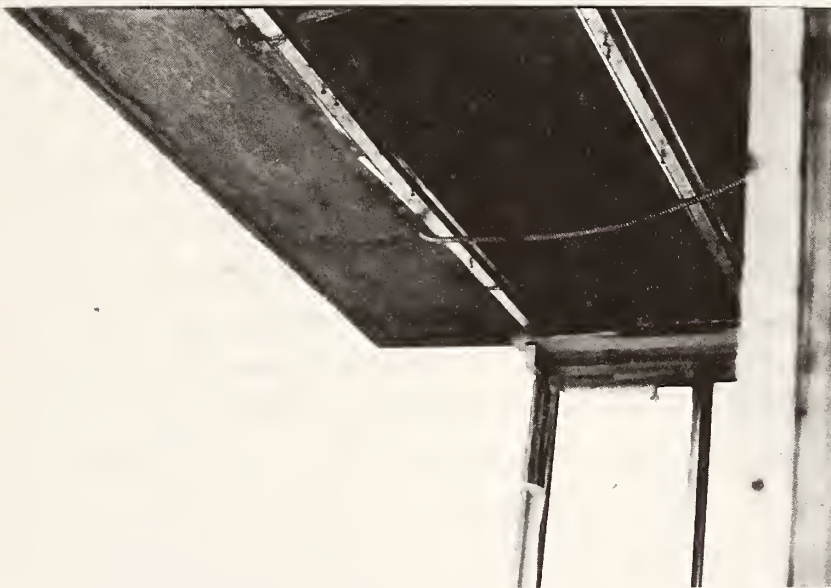
Figure 9 - Closeup of roof slab in damaged area. Looking north.

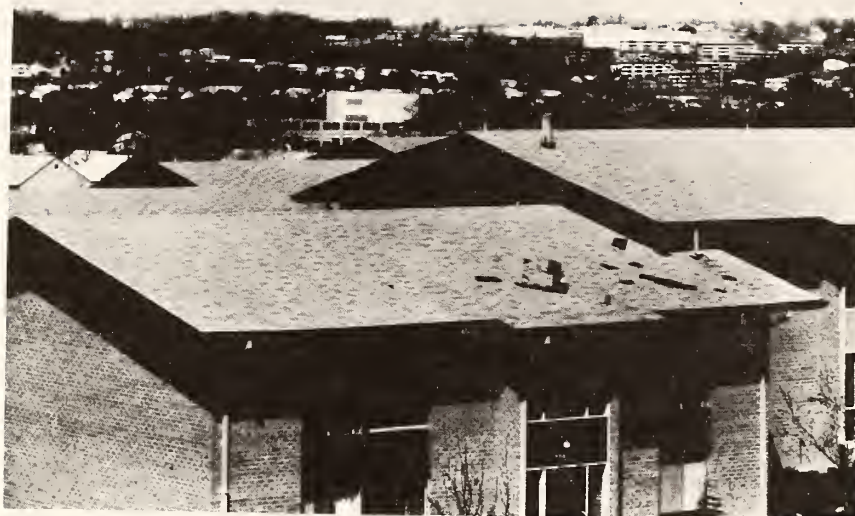
Figure 10 is a rooftop view which shows a portion of a garden apartment complex consisting of two and three-story, wood-frame, brick veneer structures. The end walls of three buildings in this complex were damaged as a result of the brick veneer flexing and separating from the sheathing and wood framing. Figure 11 shows the most severe of the three cases of endwall damage. The brick veneer failed over a large area of the wall. Eyewitnesses reported a transverse deflection of approximately 6 to 8 inches (15 to 20 cm) in the brick veneer before the failure occurred. The walls in the other two similarly affected buildings were shored (or braced) before substantial flexural failure of the veneer occurred. The prevailing wind direction is shown by the arrow in figure 11. The brick veneer was connected to the wood framing by corrugated steel ties. Evidence of broken ties as well as of the ties which were pulled out from the wood construction was found in the field investigation.

*Figure 10 - Rooftop view of garden apartments damaged by wind.
Looking northwest.*

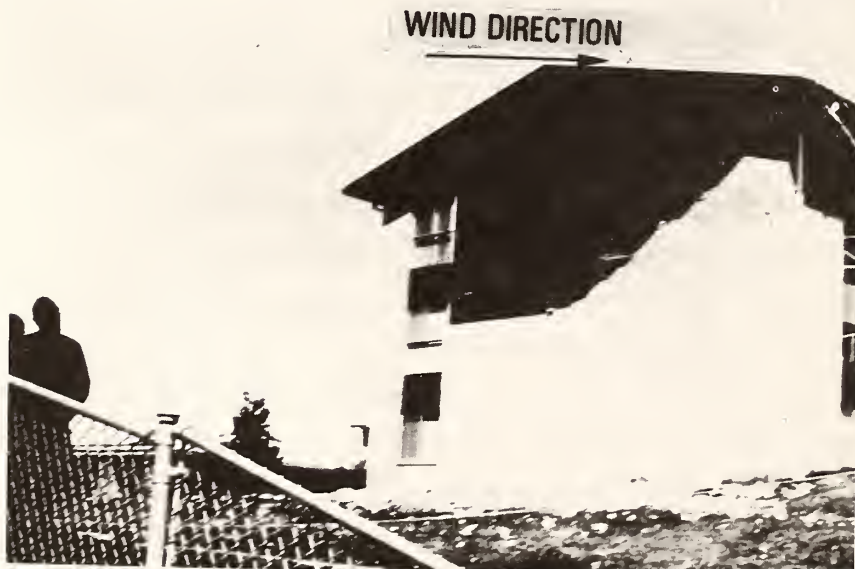
The wind direction, which was parallel to the wall, probably caused suction to act on the brick veneer. Two possible failure mechanism are envisioned: 1. the outward deflection of the gable wall could have exceeded the deflection tolerance of the masonry veneer; 2. the ties could have been too weak or too flexible to prevent a separation between the masonry veneer and the wood framing. The location of the failure area relative to the floor diaphragms which restrain the outward deflection of the wood framing seems to indicate that the failure in this case was caused by separation between the masonry veneer and the wood framing. There also seems to be evidence that the brick veneer could have moved substantially outward before the ties between the brick veneer and the wood framing were actually structurally engaged. This is illustrated by figure 12, which shows a tie connected to a brick taken from the site. The only nail hole in that tie through which a nail was driven is shown by the arrow. The distance of this nail hole from the back face of the brick indicates that the brick could have moved outward substantially before the tie was tight enough to be structurally engaged. Figure 13 shows one of two endwalls which was braced because it was flexing excessively. A total failure

*Figure 11 - Damaged brick veneer endwall in a 3-story building.
Looking north.*

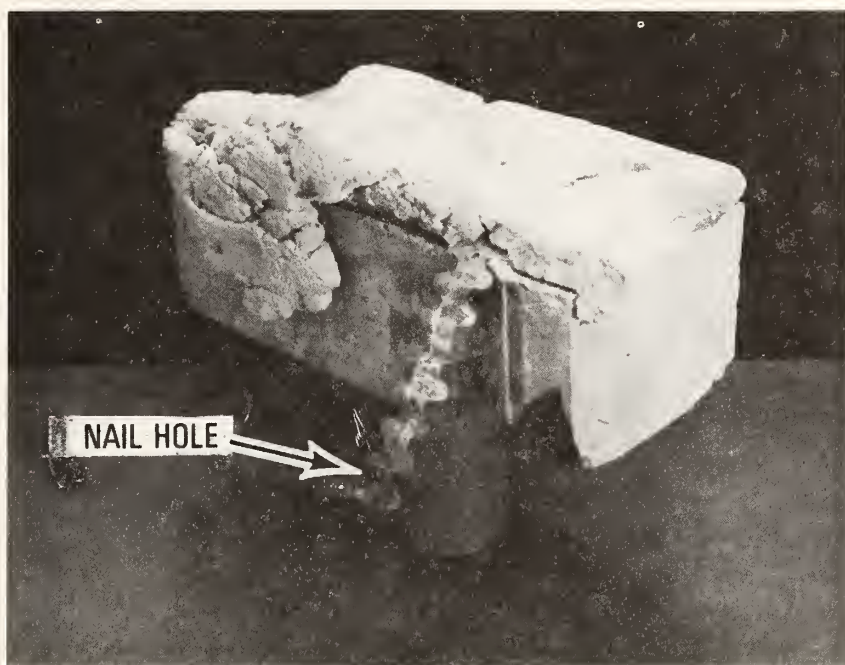
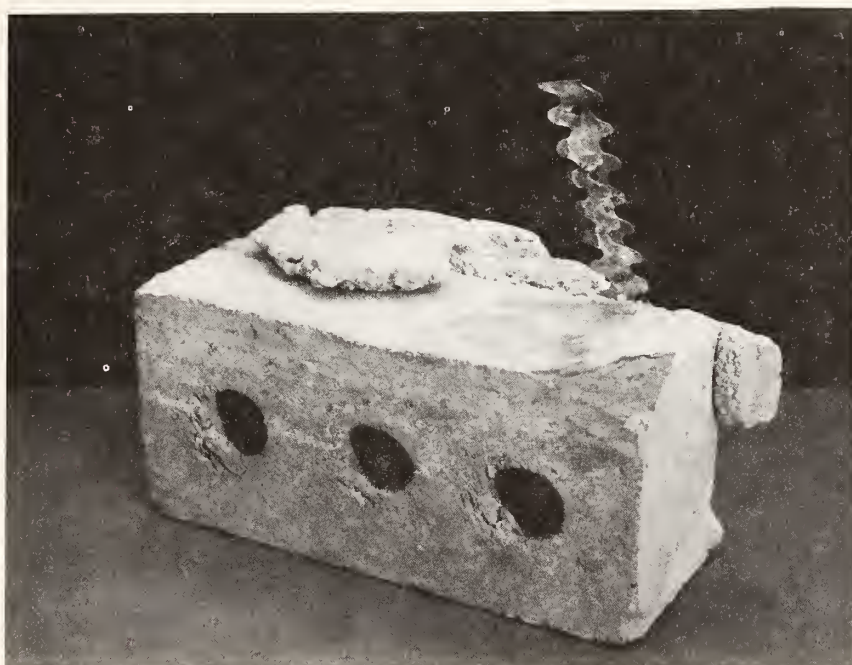
Figure 12 - Two views of a brick and connected tie taken from the endwall debris.

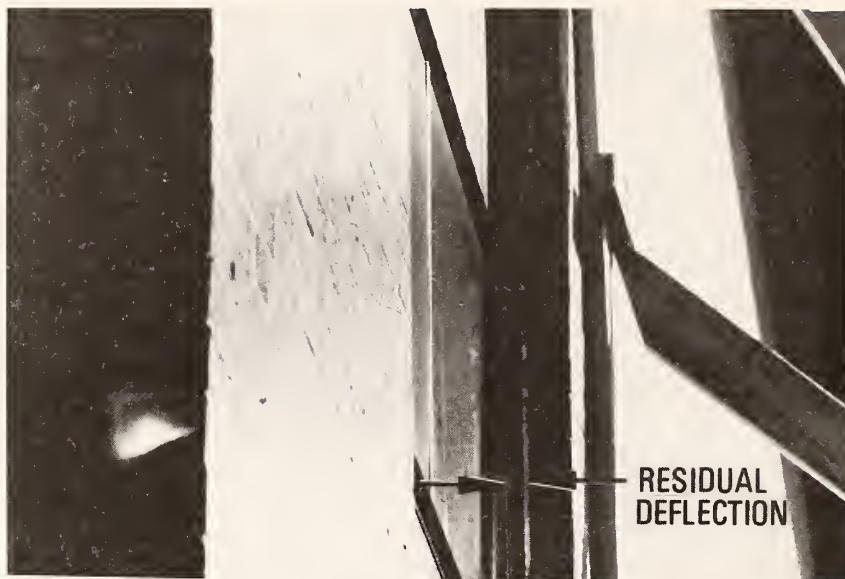
of the veneer was prevented by the bracing. The two arrows show the distance between the present location of the window and its original location relative to the veneer (identified by the remnants of the caulking). Note that the wall moved out considerably. The deflection seen in the picture is actually the residual deflection that remained after bracing. The maximum deflection during the wind storm probably substantially exceeded the deflection seen here. Figure 14 shows the second wall which had to be braced during the storm. It is evident that the strength or stiffness deficiency in the veneer construction was not limited to the building where complete veneer failure occurred.

Figure 13 - A brick veneer endwall braced because of excessive flexing.

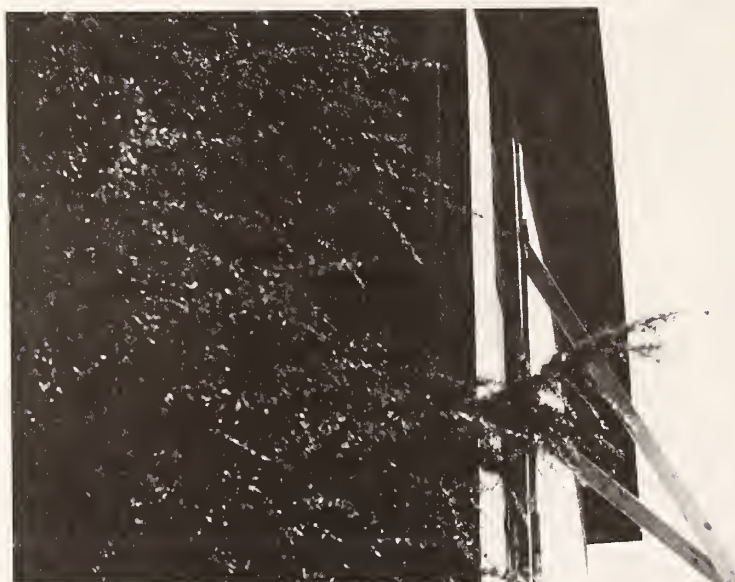
Figure 14 - A second endwall braced because of excessive flexing.

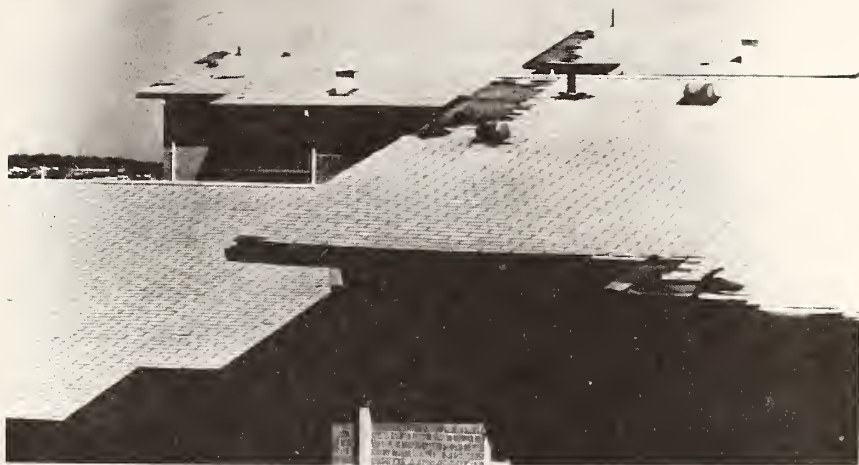
Some of the roof damage in the same apartment complex is shown in figure 15. It occurred mostly near the windward edges of the roofs. It should be noted that not only were roof shingles ripped out, but also, in some instances, the supporting plywood sheets failed. Failure of the plywood sheets tended to occur at the overhanging parts of the roofs. Figure 16 shows a damaged roof under repair. The original projecting purlins which faced the direction of the wind were ripped out and had to be replaced. A measure taken to strengthen the new projecting purlins is shown in figure 17; the timber cleat identified by the arrow was added and nailed to the truss and the projecting purlin respectively. In this manner resistance against uplift pressure was provided.

Figure 15 - Typical roof damage occurring along the windward edges. Looking north.

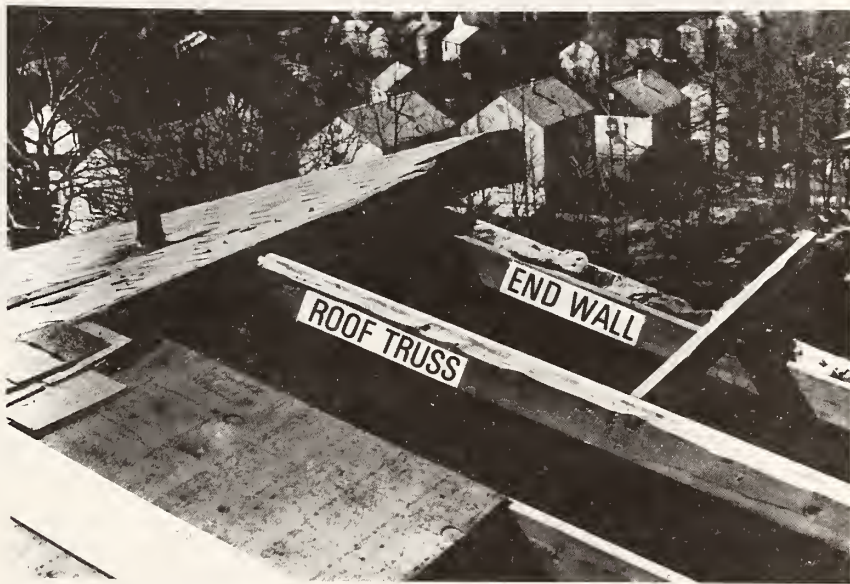
Figure 16 - Partial view of a damaged roof under repair.

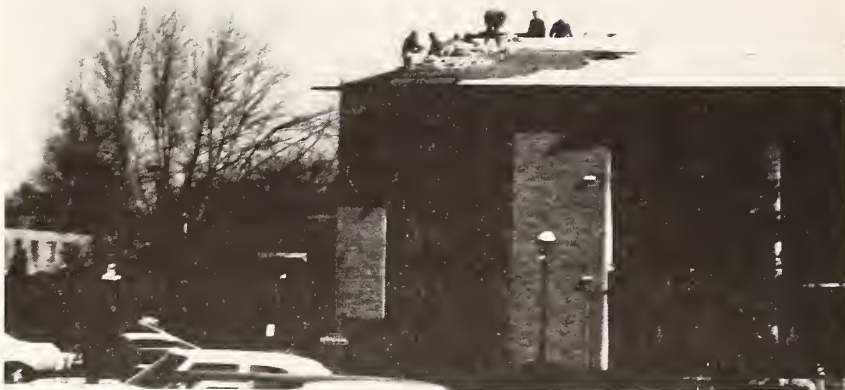
An overall view of the damaged building under repair is shown in figure 18. Figure 19 shows a closer view of the damaged wall and roof overhang. Figure 20 shows a similar undamaged wall in an adjacent building.

Figure 18 - Partial view of a damaged roof overhanging a gable wall. Looking northwest.

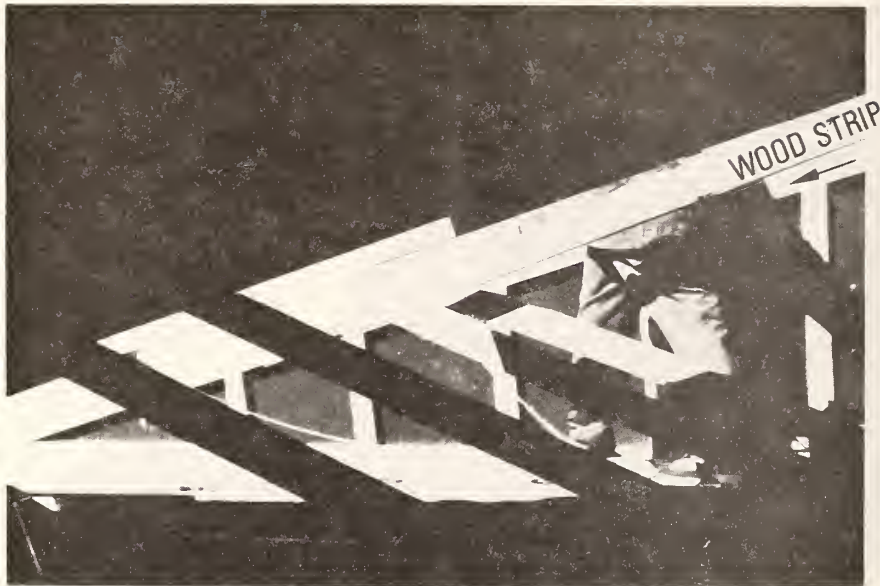
Figure 21 - Details along the back side of the damaged gable wall. Looking west.

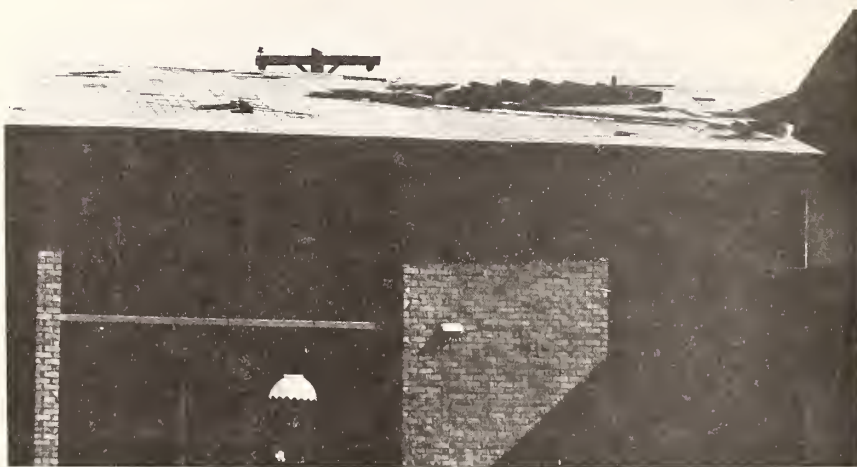
It should be noted that although the gable wall was actually a brick veneer wall up to the upper ceiling level, the wood frame structure was not continued beyond that level. Rather, wood strips were nailed to a fiberboard sheathing which was backed up against the brick veneer. This detail is shown in figure 21. Purlins were then nailed to these wood strips which are shown by the arrow. Lateral support for the top of the cantilevering brick wall was provided by these purlins which were framed into the first roof truss (following the gable wall) and by the plywood sheathing resting on top of these purlins. When the purlins and the plywood sheathing were lifted up by the wind, the brick wall lost its lateral support and was subsequently pushed in. The cantilevering roof section was completely broken off and came to rest on the roof of the building as shown in figure 22.

Figure 22 - View of a portion of the damaged overhanging roof.

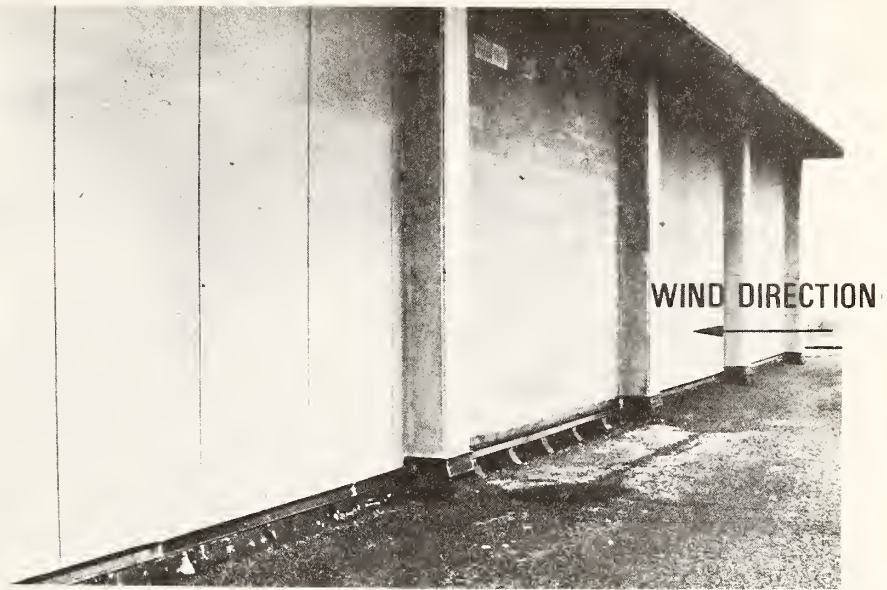
Figure 23 shows part of a 13 ft (4.0 m) high penthouse which is built on top of a 12-story office building. The office building has a flat roof and the penthouse, which houses mechanical equipment, is located about 15 ft (4.6 m) from the edge of the flat roof. The structure of the penthouse consists of a concrete frame with infill masonry walls. As can be seen in figure 23, most of the masonry walls are covered by decorative stucco. Typically, the infill wall is 8 in (20.3 cm) thick hollow concrete block. The columns are 30 in x 22 in (76.2 cm x 55.9 cm) and the masonry panels are 13 ft (4.0 m) wide. The roof overhang shown in the figure projects from a 12 in (30.5 cm) deep beam which rests on top of the concrete block panels, thus making the panels infill panels inside a concrete frame. There is also a concrete beam along the bottom of the masonry panels. The prevailing wind direction was normal to the plane of the wall and the loads acted inward as shown by the arrow in figure 23. The effect of the wind was to cause a violent dynamic response of the masonry infill walls. Eyewitnesses reported that "the wall was wavering visibly in an inward and outward fashion, apparently pivoting about its bottom." It is difficult to interpret this statement exactly but evidently the wall was flexing in and out with an amplitude large enough to be clearly distinguishable by an observer. Inadequate restraint at the top of the wall may have contributed to the large deflections. The flexing of the wall did not lead to a failure, although there is substantial evidence of local distress. Figure 24 shows a view of the bottom of the wall at the interior of the penthouse. Note the crack between the bottom course of the masonry and the concrete beam at the bottom of the wall. Figure 25 shows a similar crack between the top of the masonry wall and the top concrete beam. The picture was taken in the interior of the penthouse in a part which is not covered by a roof (the cooling tower area). Figure 26 shows bracing which was installed in the interior of the penthouse during the storm in order to stabilize the infill panels. The building was evacuated during the storm because of fear that collapse of infill walls might

Figure 23 - Exterior view of the damaged masonry walls of a mechanical equipment penthouse. Looking south.

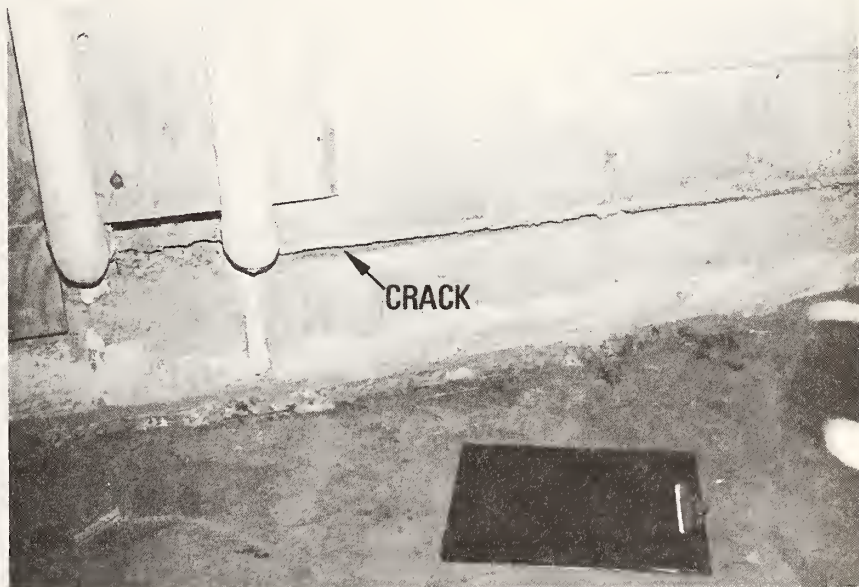
Figure 24 - View of the bottom of a damaged wall at the interior of the penthouse.

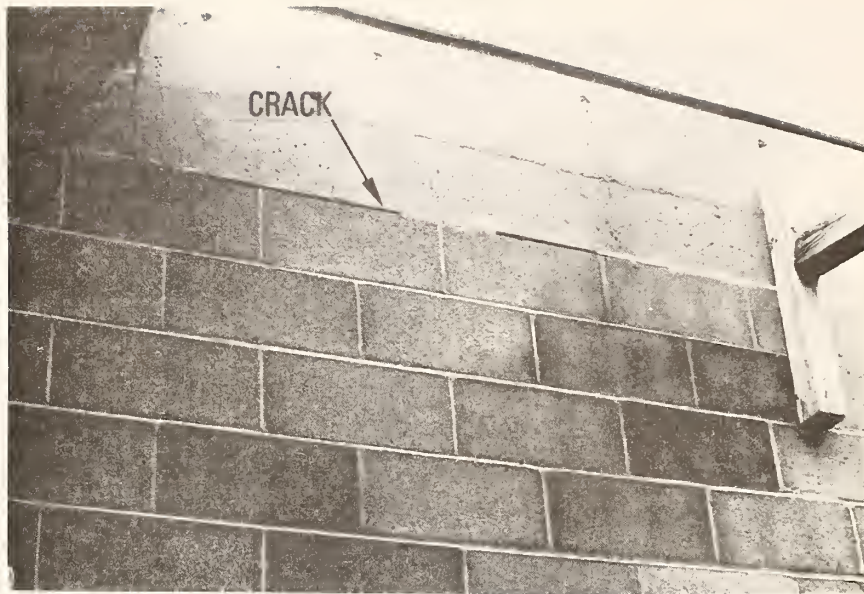
Figure 25 - Mortar crack between top of masonry wall and bottom of concrete beam.

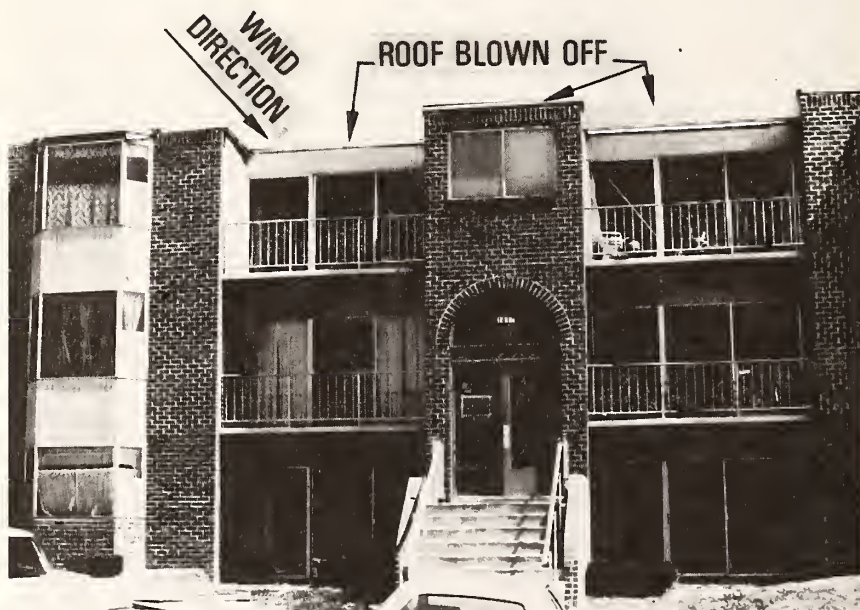
Figure 28 - Front elevation of a building which sustained roof damage. Looking east.

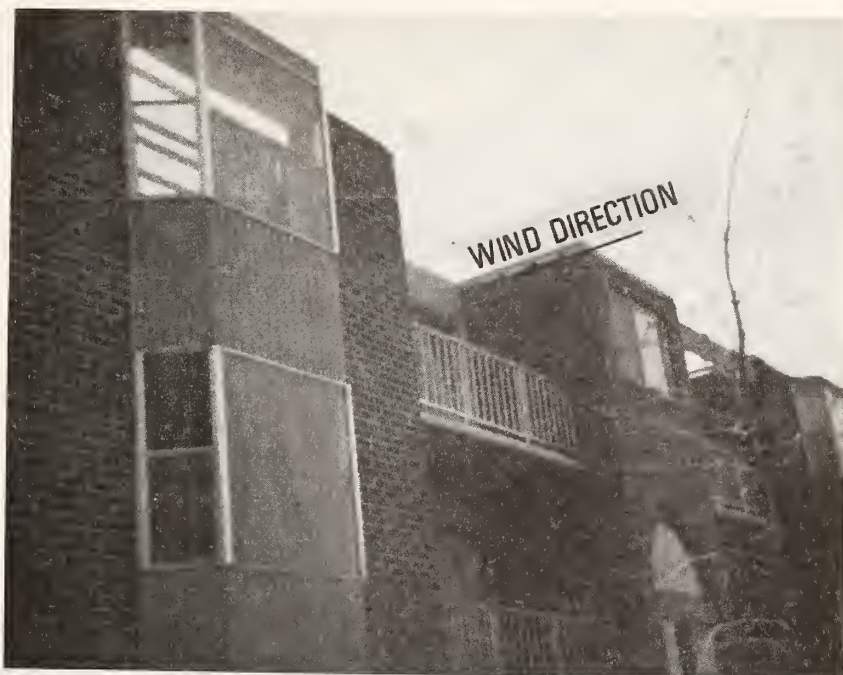
Figure 29 - Closeup view of damage showing loss of roof over living unit and balcony.

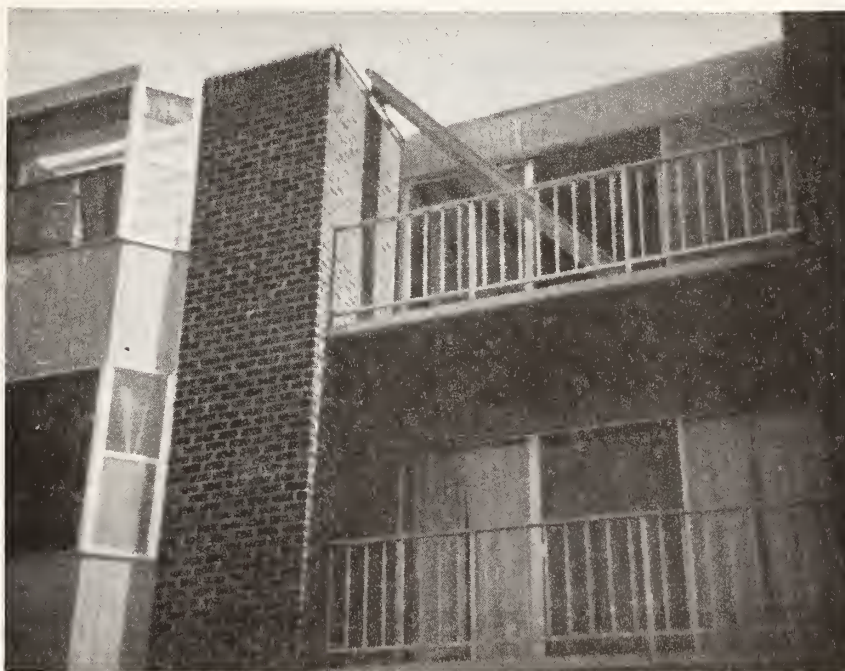
Figure 30 - Closeup view of damage above third-story balcony.

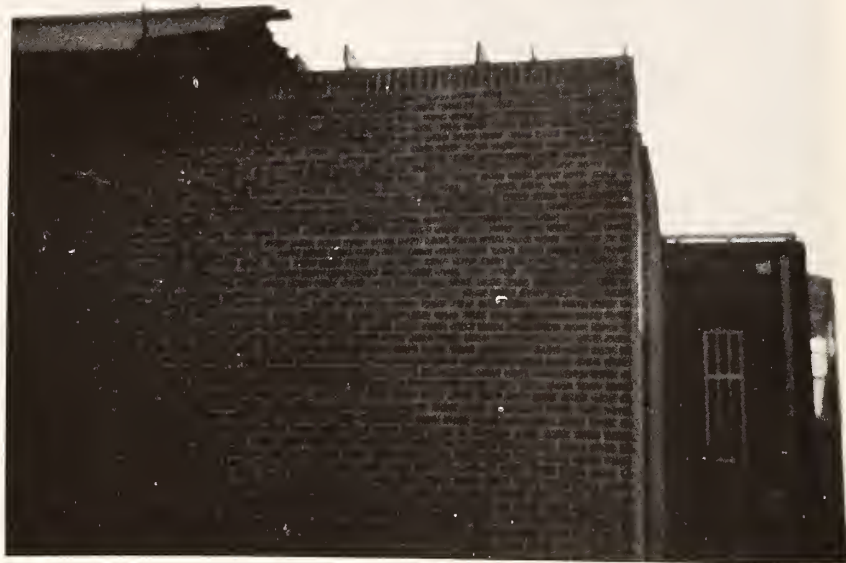
Figure 31 - Side view of damaged building showing partial destruction of roof.

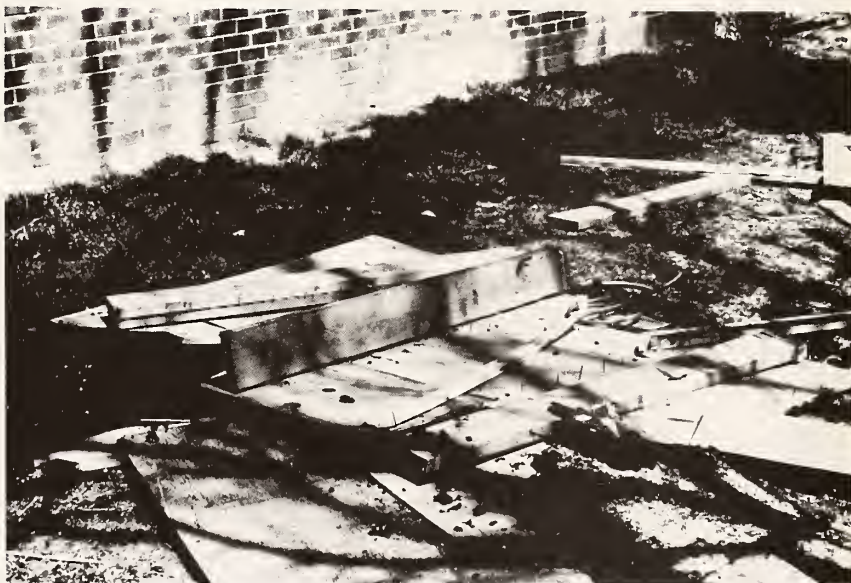
Figure 32 - Ground-level view of some wood framing and sheathing from a damaged roof.

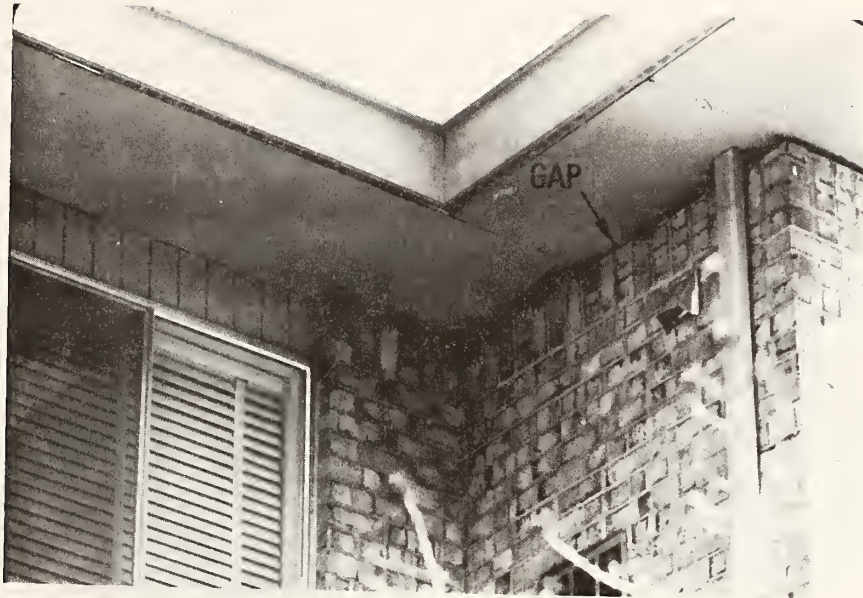
Figure 33 - Residual separation between soffit and masonry wall caused by uplift on roof overhang.

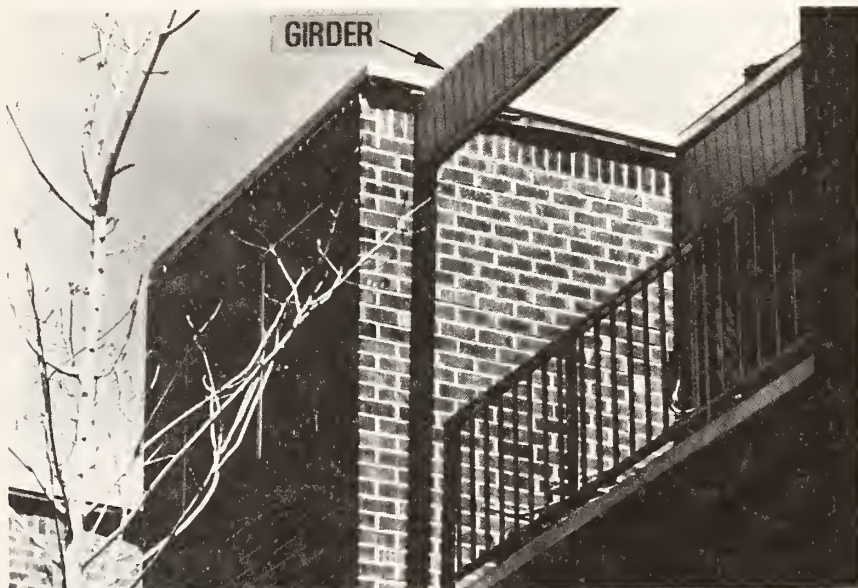
Figure 34 - Girder which supported portion of roof that covered balcony.

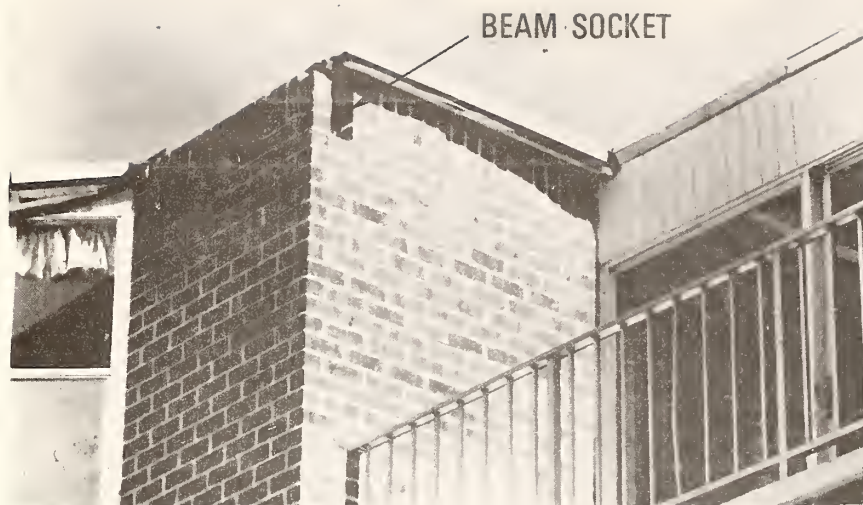
Figure 35 - A balcony above which the roof and supporting girder were removed.

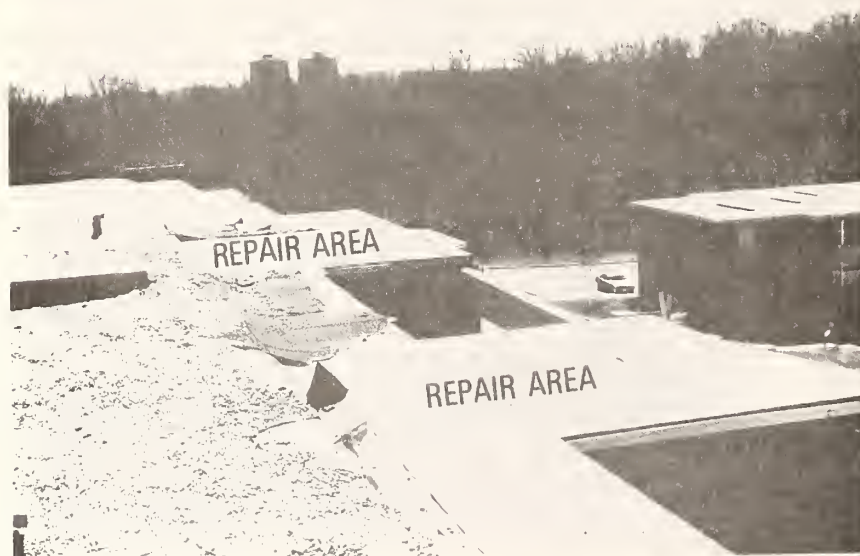
Figure 36 - Overall view of roof under repair.

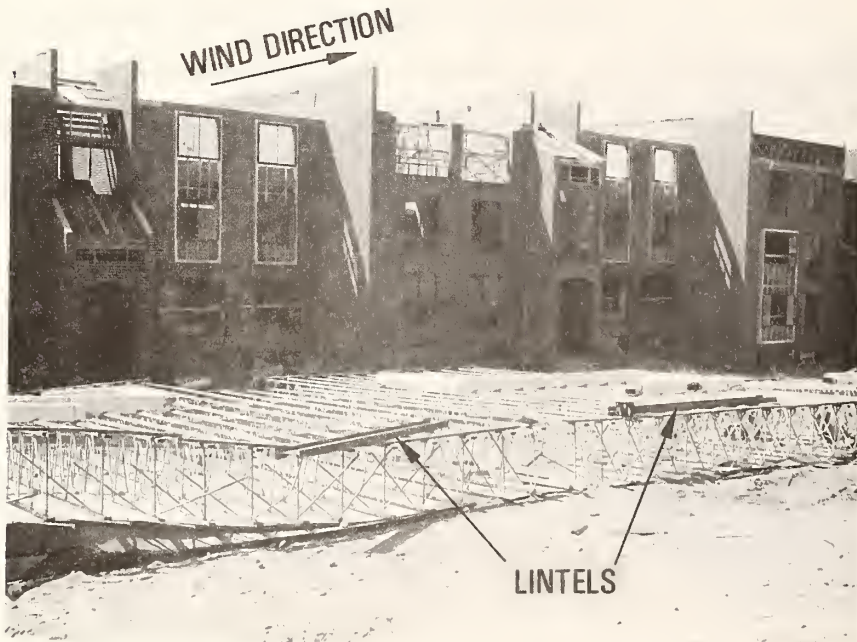
Figure 37 shows a three-story garden apartment building. This is one of the completed units which suffered no damage. Figure 38 shows a row of the same type of units under construction. The prevailing wind direction is indicated by the arrow. Note that in the completed unit (figure 37) the truss structures which support the roofs are closed by siding, giving the appearance of a mansard. Figure 38 shows part of the roofs which were removed by the wind and deposited in front of the buildings under construction. A closer look at an undisturbed roof assembly in place is shown in figure 39. Figures 40 and 41 show details of the roof assemblies which were lifted up, overturned and deposited on the ground. The truss structure had wooden top and bottom chords and galvanized steel tubing as diagonal truss members. The top of the roof was covered by 1/2 in (1.3 cm) thick plywood sheathing. Although this plywood sheathing was in place, the built-up roofing had not yet been installed. The span length of the trusses was 49 ft (14.9m) and spacing between trusses was 24 in (61.0 cm). Connections of the roof trusses to the masonry walls are shown in figures 42, 43 and 44. Figure 44 shows that not only was the roof truss structure removed, but also a steel beam which served as a lintel over a window opening. One of these lintels, in place, is marked by the arrow in figure 45. Two of the displaced lintels are seen, still attached to the trusses in figure 38. The failure of these roofs is probably attributable to two causes: 1. the sides of the trusses were open and the windows were not completed, thus providing openings which caused pressure buildup on the underside of the roof sheathing; this pressure, together with suction acting on the top of roof surface exerted a considerable upward force; 2. the built-up roofing was not yet in place to add weight which could have contributed to the resistance to uplift pressure. Figure 45 shows the details of roof trusses on units which were under construction and which were not damaged by the wind.

Figure 38 - Front elevation of several buildings under construction from which the roofs were lifted and dropped on the ground.

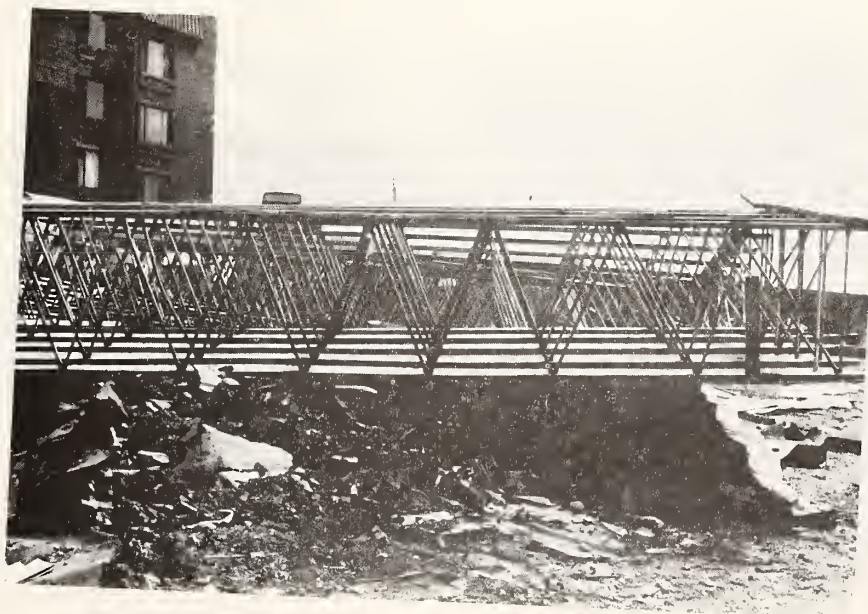
Figure 40 - Side elevation of the roof assemblies lifted up and deposited on the ground.

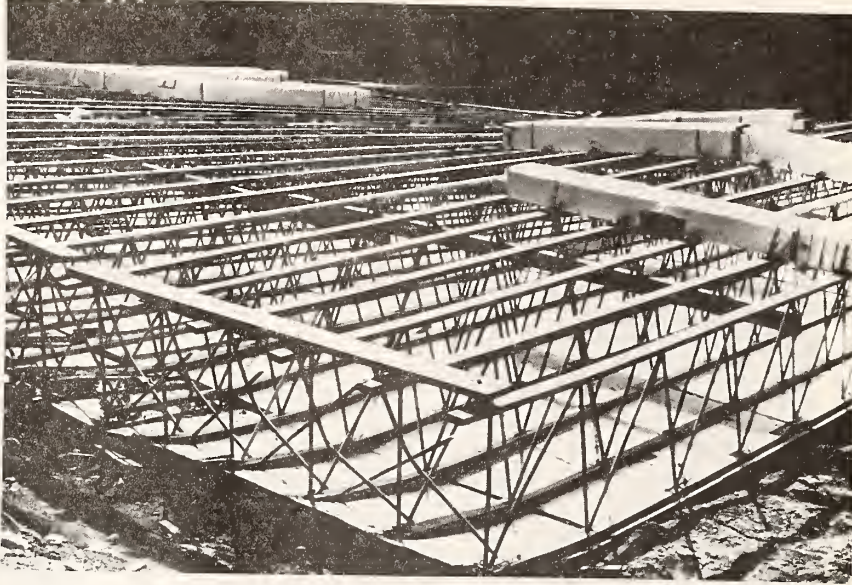
Figure 41 - Closeup view of overturned roof assemblies.

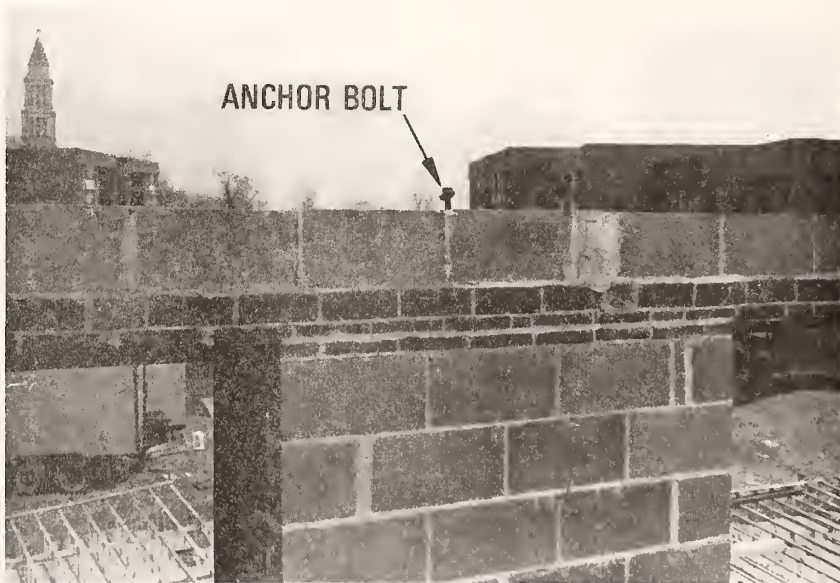
Figure 42 - A front masonry wall with projecting bolt for anchoring the roof assembly.

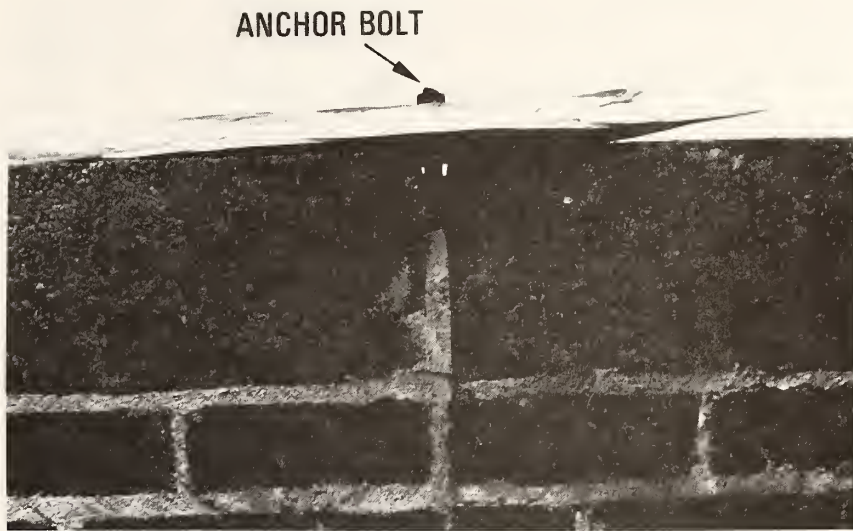
Figure 43 - A portion of a wood bearing plate and a connecting anchor bolt remain atop masonry wall.

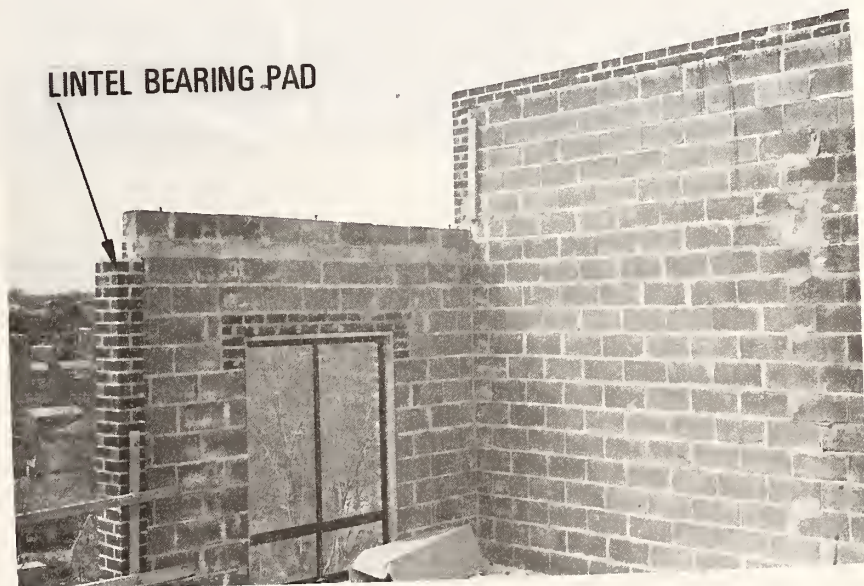
Figure 44 - Elevation of a rear wall from which the roof assembly and lintel beam have been removed. Looking northwest.
